# ProDecon® Case Study UK Refinery

## Pyrophoric Direct Reduction Plant

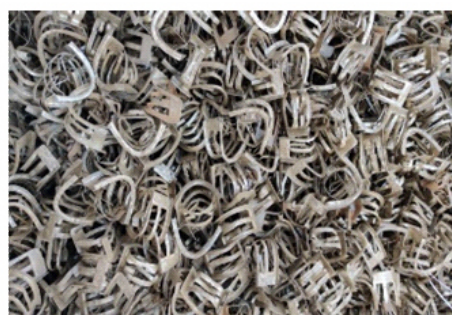
ProDecon successfully completed the project within the allowable timeframe. Sampling and testing proved the efficiency of decontamination and pyrophoric neutralisation. The manways were opened to allow safe packing removal without exothermic reaction and potential fire. The subsequent packing removal was able to proceed immediately and on site comments from the mechanical contractor and client's staff indicated that the work was able to proceed faster than expected. The cleanliness of the vessels' internals was reported to be very good as shown below.

*Figure 1: Column packing after decontamination*
