# ProDecon® Case Study

## Petrochemical - Olefins Unit, Abu Dhabi

### Quench System Decontamination

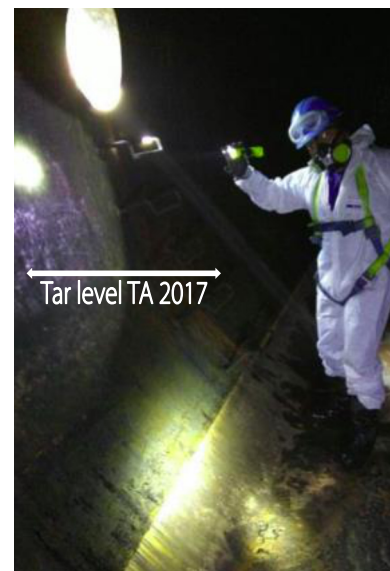
Access was now safe with 0ppm Benzene recorded and no requirement for BA as experienced during previous shutdowns, leading to increased productivity of the mechanical team. The remaining residues were reported as hard brittle material and much easier to physically remove than the previous sticky sludge.

The picture to side is from the inside of the tar settler which highlights the reduction in sludge level versus the previous turnaround. The process improved the safety of the turnaround event for all on the unit and reduced the schedule.
